Pentium® III Xeon™ Processor Specification Update

Release Date: November 1999

Order Number: 244460-008

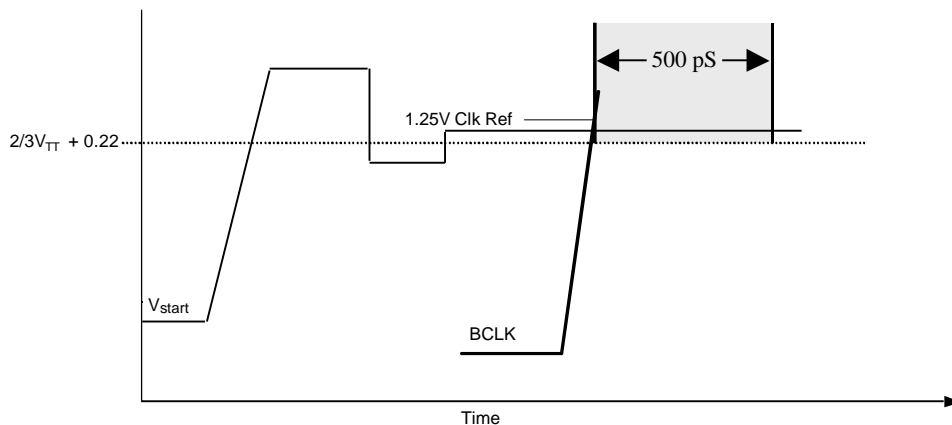
Implication: The deviation from the published specification results in decreased noise margin on the RS0# processor input. This decreased noise margin has been observed to be particularly detrimental in system environments where the RS0# processor input is being driven by an I/O buffer with a pull-up device (such as a p-channel transistor) that is switched off mid-cycle. Systems which employ I/O buffers that keep the pull-up device on for the entire cycle are significantly less affected by this erratum. The reduction in noise margin may lead to the generation of BINIT# (when enabled) resulting in a system reset, otherwise this condition may lead to a system "hang" condition.

Workaround: If a system design cannot meet the specification deviation, the following areas should be carefully examined to assure that additional margin exists in order to compensate for any deficit observed with respect to the newly characterized $V_{IH(MIN)}$ specification:
